# Access Compliance Report Public Rights-of-Way (Curb Ramps)

Main Street: CHRISTY\_LN Cross Street: WALKER\_LEE\_DR Location: NE

ADA ID: RPRK211207132912 Ramp Type: Type 1 - Perpendicular Diagonal Initial Pass/Fail: Pass Overall Compliance: No Severity Score: 10

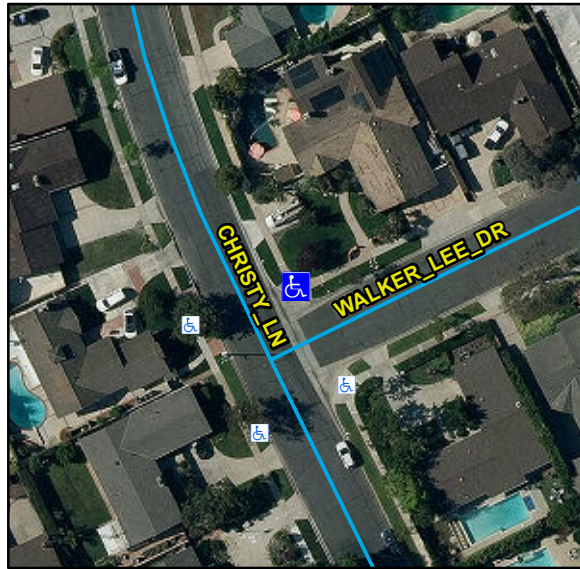
| Compliance | Description | Data | Compliance | Description | Data |
|---|---|---|---|---|---|
| Yes | Landing Cross Slope (%) | 1.4 | No | DWS Provided | No |

Remove & Replace Curb Ramp With Two New Directional Ramps or Equivalent.

R204.3, R305, STD 1115
