# Access Compliance Report Public Rights-of-Way (Curb Ramps)

Main Street: BELLWOOD\_RD Cross Street: WALKER\_LEE\_DR Location: NE

ADA ID: RPRK211207134527 Ramp Type: Type 1 - Perpendicular Diagonal Initial Pass/Fail: Pass Overall Compliance: No Severity Score: 10

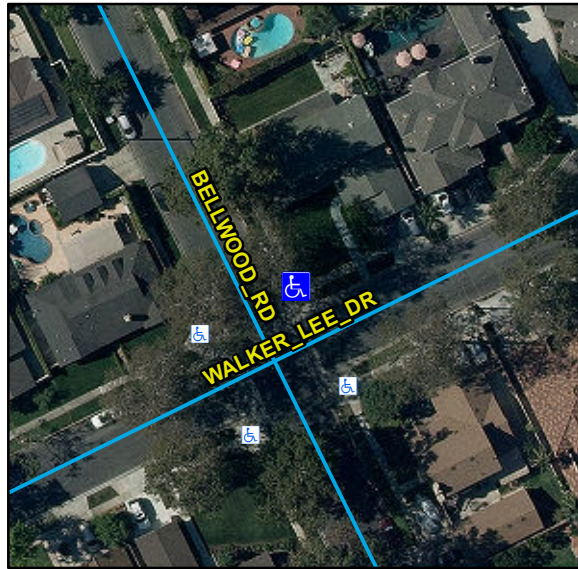
| Compliance | Description | Data | Compliance | Description | Data |
|---|---|---|---|---|---|
| Yes | Landing Cross Slope (%) | 2 | No | DWS Provided | No |

Remove & Replace Curb Ramp With Two New Directional Ramps or Equivalent.
