# Access Compliance Report Public Rights-of-Way (Curb Ramps)

Main Street: WALKER\_LEE\_DR Cross Street: BELLWOOD\_RD Location: SE

ADA ID: RPRK211207134833 Ramp Type: Type 1 - Perpendicular Diagonal Initial Pass/Fail: Pass Overall Compliance: No Severity Score: 10

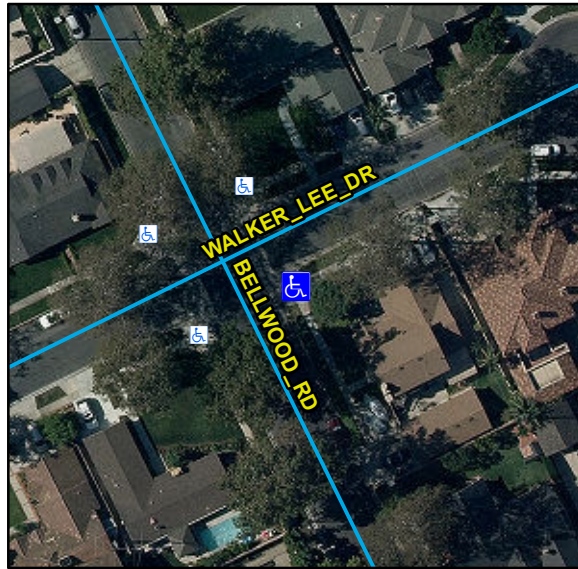
| Compliance | Description | Data | Compliance | Description | Data |
|---|---|---|---|---|---|
| Yes | Landing Cross Slope (%) | 1.7 | No | DWS Provided | No |
| No | Gutter Lip Height (in) | 0.25 | | Road Run Slope (%) | 1.4 |

Remove & Replace Curb Ramp With Two New Directional Ramps or Equivalent. Grind Gutter Lip.
