# Access Compliance Report Public Rights-of-Way (Curb Ramps)

Main Street: WALKER\_LEE\_DR Cross Street: BELLWOOD\_RD Location: NW

ADA ID: RPRK211207135106 Ramp Type: Type 1 - Perpendicular Diagonal Initial Pass/Fail: Fail Overall Compliance: No Severity Score: 2

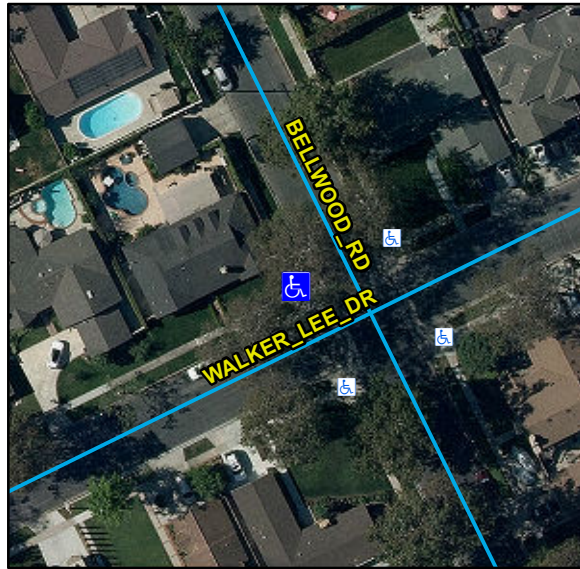
| Compliance | Description | Data | Compliance | Description | Data |
|---|---|---|---|---|---|
| No | Ramp Cross Slope (%) | 2.7 | N/A | Flare Traversable LT | N/A |
| No | Gutter Lip Height (in) | 0.25 | | Road Run Slope (%) | 0.2 |

Remove & Replace Curb Ramp With Two New Directional Ramps or Equivalent. Grind Gutter Lip.
