# Access Compliance Report Public Rights-of-Way (Curb Ramps)

Main Street: BELLWOOD\_RD Cross Street: WALKER\_LEE\_DR Location: SW

ADA ID: RPRK211207135302 Ramp Type: Type 1 - Perpendicular Diagonal Initial Pass/Fail: Pass Overall Compliance: No Severity Score: 10

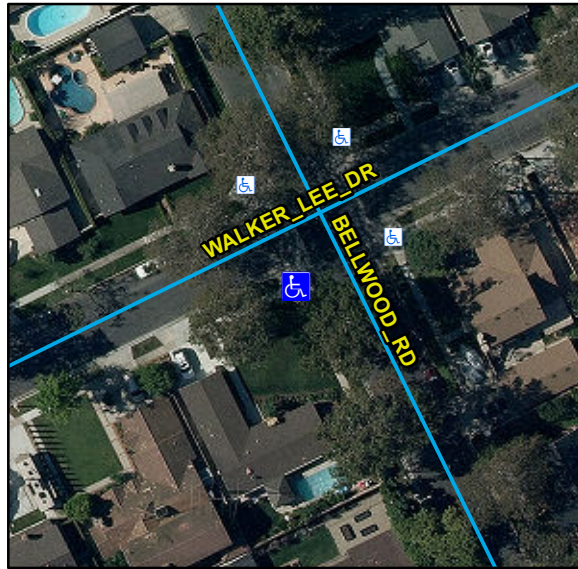
| Compliance | Description | Data | Compliance | Description | Data |
|---|---|---|---|---|---|
| Yes | Landing Cross Slope (%) | 1.6 | No | DWS Provided | No |

Remove & Replace Curb Ramp With Two New Directional Ramps or Equivalent.

R204.3, R305, STD 1115
