# Access Compliance Report Public Rights-of-Way (Curb Ramps)

Main Street: BELLWOOD\_RD Cross Street: BRIMHALL\_DR Location: NW

ADA ID: RPRK211207135636 Ramp Type: Type 1 - Perpendicular Diagonal Initial Pass/Fail: Fail Overall Compliance: No Severity Score: 0

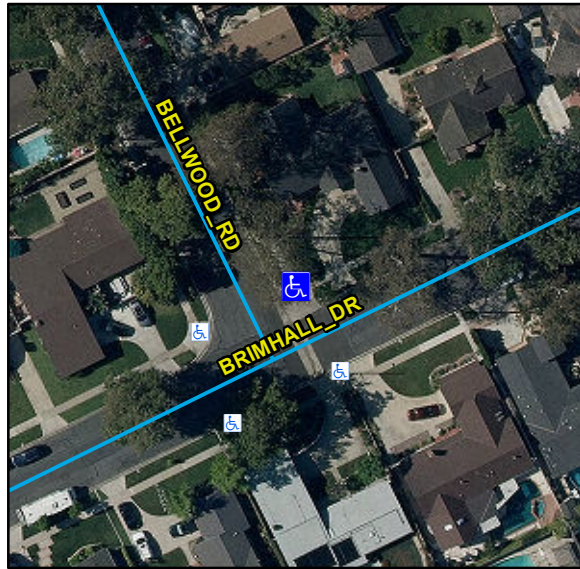
| Compliance | Description | Data | Compliance | Description | Data |
|---|---|---|---|---|---|
| Yes | Ramp Run Slope (%) | 5.7 | N/A | Flare Slope LT (%) | N/A |
| Yes | Ramp Cross Slope (%) | 2.2 | N/A | Flare Traversable LT | N/A |
| | Crossing 1 Slope (%) | 9.4 | | Crossing 2 Slope (%) | 3.1 |

Remove & Replace Curb Ramp With Two New Directional Ramps or Equivalent.

R304.2.2, R204.3, STD 1115
