# Access Compliance Report Public Rights-of-Way (Curb Ramps)

Main Street: OAK\_WAY\_DR Cross Street: TIGERTAIL\_DR Location: NE

ADA ID: RPRK211208111319 Ramp Type: Type 1 - Perpendicular Diagonal Initial Pass/Fail: Pass Overall Compliance: No Severity Score: 20

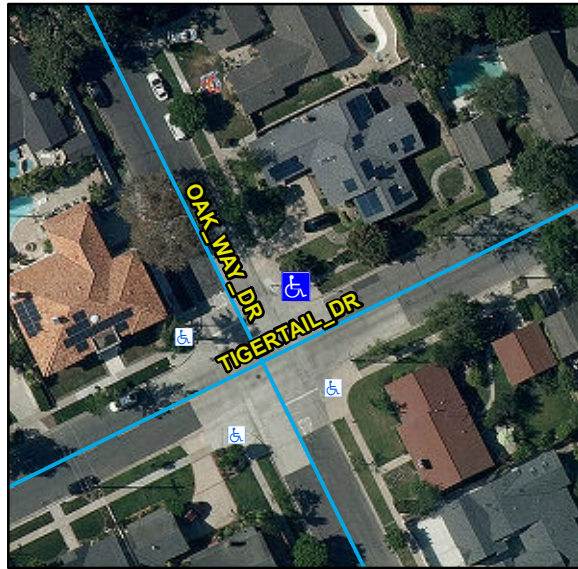
| Compliance | Description | Data | Compliance | Description | Data |
|---|---|---|---|---|---|
| N/A | Ramp Length (in) | 130 | N/A | Flare Type LT | |
| Yes | Ramp Run Slope (%) | 6.6 | N/A | Flare Slope LT (%) | 15.4 |
| No | Landing Width (in) | N/A | N/A | Flare Slope RT (%) | 11.9 |
| No | Landing Run Slope (%) | N/A | N/A | Flare Traversable RT | No |
| No | Landing Cross Slope (%) | N/A | No | DWS Provided | No |
| No | Gutter Lip Height (in) | 0.25 | | Road Run Slope (%) | 1.6 |
| No | Gutter Cross Slope (%) | 2.7 | | | |

Remove & Replace Curb Ramp With Two New Directional Ramps or Equivalent. Remove & Replace Gutter.

R204.3, R304.2.1, R304.2.2-Perp, R304.3.2-Para, R304.5.3, R305, R302.7.2, STD 1115
