# Access Compliance Report Public Rights-of-Way (Curb Ramps)

Main Street: TIGERTAIL\_DR Cross Street: OAK\_WAY\_DR Location: NW

ADA ID: RPRK211208111712 Ramp Type: Type 4 - Parallel Initial Pass/Fail: Fail Overall Compliance: No Severity Score: 15

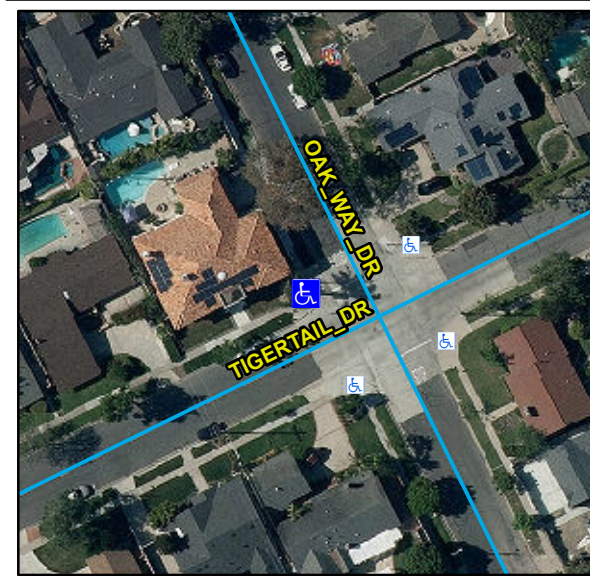
| Compliance | Description | Data | Compliance | Description | Data |
|---|---|---|---|---|---|
| No | Ramp Cross Slope LT (%) | 2.5 | No | Ramp Cross Slope RT (%) | 6.5 |

Possible Solutions:  
**Remove & Replace Curb Ramp With Two New Directional Ramps or Equivalent.**

OC Std/PROW:  
**R304.5.3, STD 1115**
