# Access Compliance Report Public Rights-of-Way (Curb Ramps)

| Main Street: TIGERTAIL_DR | | Cross Street: OAK_WAY_DR | | Location: | SE |
| ADA ID: RPRK211208112017 | Ramp Type:Type 1 - Perpendicular Diagonal Initial Pass/Fail: Fail | | Overall Compliance: No | Severity Score: | 2 |

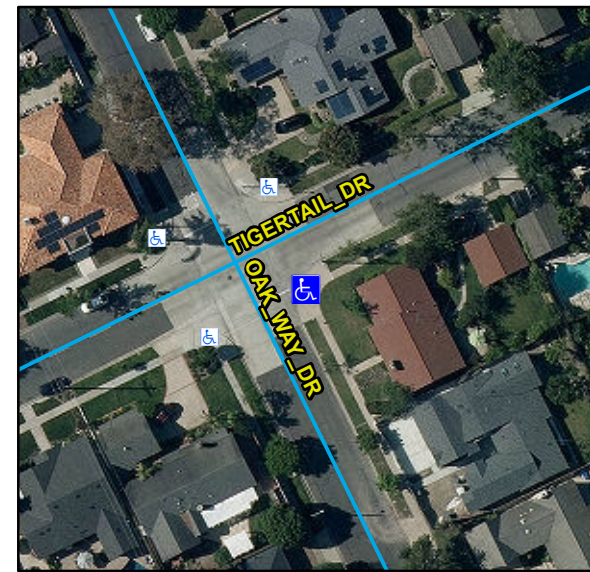
| Compliance | Description | Data | Compliance | Description | Data |
|---|---|---|---|---|---|
| No | Ramp Cross Slope (%) | 2.4 | N/A | Flare Traversable LT | N/A |
| No | Gutter Lip Height (in) | 1 | | Road Run Slope (%) | 2.8 |

**Remove & Replace Curb Ramp With Two New Directional Ramps or Equivalent. Grind Gutter Lip.**

**R204.3, R304.5.3, R302.7.2, STD 1115**
