# Access Compliance Report Public Rights-of-Way (Curb Ramps)

| Main Street: OAK_WAY_DR | | Cross Street: TIGERTAIL_DR | | Location: | SW |
| ADA ID: RPRK211208112235 | Ramp Type: Type 4 - Parallel | Initial Pass/Fail: Fail | Overall Compliance: No | Severity Score: | 15 |

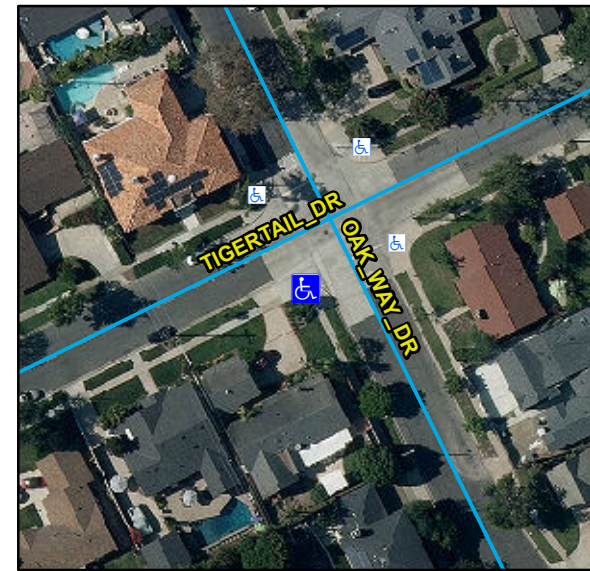
| Compliance | Description | Data | Compliance | Description | Data |
|---|---|---|---|---|---|
| No | Ramp Cross Slope LT (%) | 4.8 | No | Ramp Cross Slope RT (%) | 7 |

**Remove & Replace Curb Ramp With Two New Directional Ramps or Equivalent.**

**R304.5.3, STD 1115**

Total Cost: \$ 4000
