# Access Compliance Report Public Rights-of-Way (Curb Ramps)

| Main Street: MONTECITO_RD | | Cross Street: TUCKER_LN | | Location: | SW |
| ADA ID: RPRK211208113335 | Ramp Type: Type 4 - Parallel | Initial Pass/Fail: Fail | Overall Compliance: No | Severity Score: | 30 |

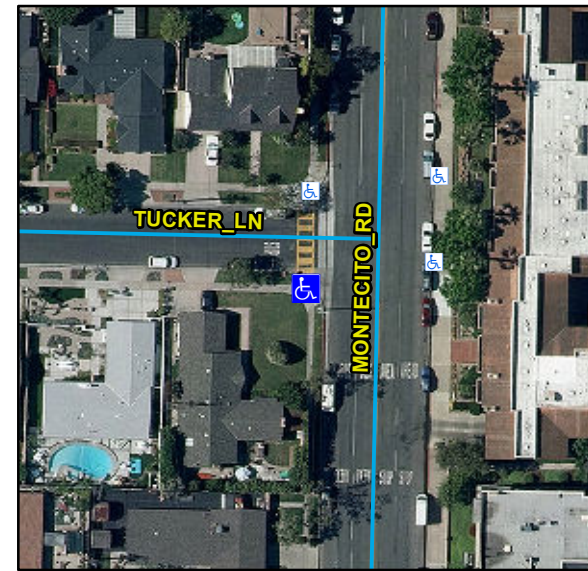
| Compliance | Description | Data | Compliance | Description | Data |
|---|---|---|---|---|---|
| Yes | Ramp Run Slope LT (%) | 1 | Yes | Ramp Run Slope RT (%) | 7.4 |
| No | Ramp Cross Slope LT (%) | 3.7 | No | Ramp Cross Slope RT (%) | 7.6 |

Possible Solutions:

**Remove & Replace Curb Ramp With Two New Directional Ramps or Equivalent.**

**R204.3, R304.5.3, STD 1115**

Total Cost: \$ 4000

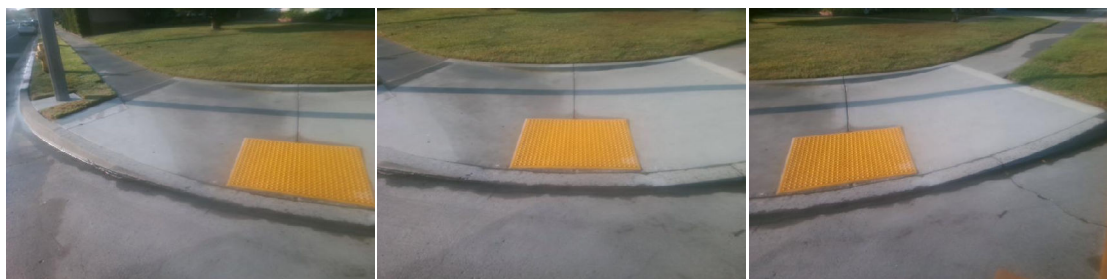
| Compliance | Description | Data | Compliance | Description | Data |
|---|---|---|---|---|---|
| N/A | Ramp Length LT (in) | 114 | N/A | Ramp Length RT (in) | 105 |
| Yes | Ramp Width LT (in) | 110 | Yes | Ramp Width RT (in) | 110 |
