# Access Compliance Report Public Rights-of-Way (Curb Ramps)

Main Street: TUCKER\_LN Cross Street: MONTECITO\_RD Location: NW

ADA ID: RPRK211208113606 Ramp Type: Type 4 - Parallel Initial Pass/Fail: Fail Overall Compliance: No Severity Score: 15

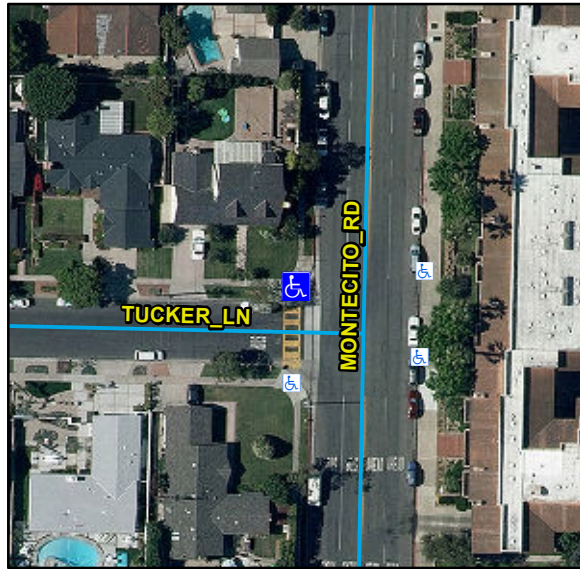
| Compliance | Description | Data | Compliance | Description | Data |
|---|---|---|---|---|---|
| Yes | Ramp Cross Slope LT (%) | 1.9 | No | Ramp Cross Slope RT (%) | 6.7 |

Remove & Replace Curb Ramp With Two New Directional Ramps or Equivalent.

R304.5.3, STD 1115

Total Cost: \$ 4000
