# Access Compliance Report Public Rights-of-Way (Curb Ramps)

Main Street: MONTECITO\_RD Cross Street: MAINWAY\_DR Location: W

ADA ID: RPRK211208113928 Ramp Type: Type 3 - Combination 1 Initial Pass/Fail: Fail Overall Compliance: No Severity Score: 5

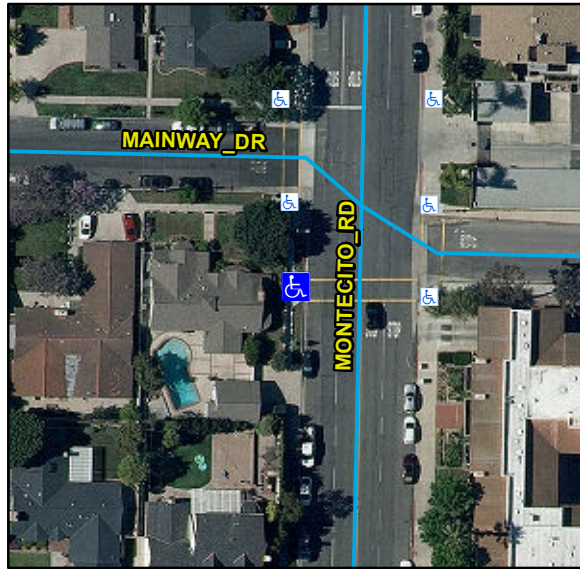
| Compliance | Description | Data | Compliance | Description | Data |
|---|---|---|---|---|---|
| No | Ramp Width LT (in) | 46 | No | Ramp Width RT (in) | 46 |
| Yes | Ramp Cross Slope LT (%) | 0.2 | No | Ramp Cross Slope RT (%) | 4.2 |

Remove & Replace Entire Ramp.

R304.5.1, R304.5.3, STD 1115
