# Access Compliance Report Public Rights-of-Way (Curb Ramps)

| Main Street: ROSSMOOR_CENTER_WAY | | Cross Street: MONTECITO_RD | | Location: | SE |
| ADA ID: RPRK211208114301 | Ramp Type: Type 4 - Parallel | Initial Pass/Fail: Fail | Overall Compliance: No | Severity Score: | 35 |

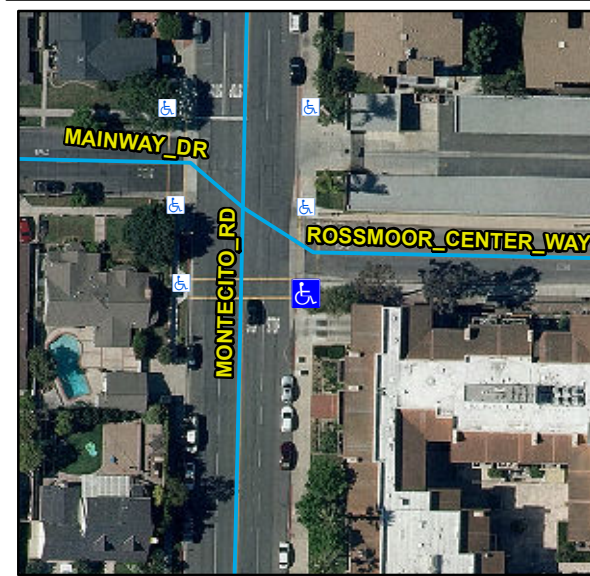
| Compliance | Description | Data | Compliance | Description | Data |
|---|---|---|---|---|---|
| No | Ramp Width LT (in) | 46 | Yes | Ramp Width RT (in) | 98 |
| Yes | Ramp Run Slope LT (%) | 7.2 | No | Ramp Run Slope RT (%) | 12.5 |
| Yes | Ramp Cross Slope LT (%) | 0.4 | No | Ramp Cross Slope RT (%) | 4.1 |

**Remove & Replace Curb Ramp With Two New Directional Ramps or Equivalent.**

**R304.5.1, R304.3.2, R304.5.3, STD 1115**

Total Cost: \$ 4000
