# Access Compliance Report Public Rights-of-Way (Curb Ramps)

Main Street: N/A Cross Street: ROSSMOOR\_CENTER\_WAY Location: SW

ADA ID: RPRK211208114639 Ramp Type: Type 1 - Perpendicular Diagonal Initial Pass/Fail: Fail Overall Compliance: No Severity Score: 2

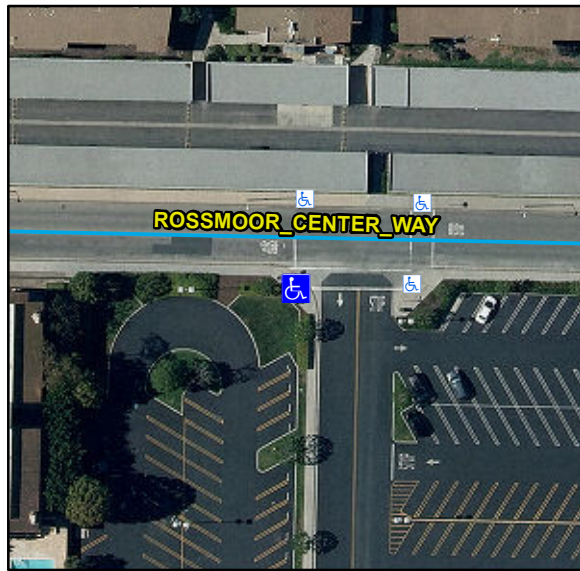
| Compliance | Description | Data | Compliance | Description | Data |
|---|---|---|---|---|---|
| No | Ramp Cross Slope (%) | 3.6 | N/A | Flare Traversable LT | N/A |
| No | Gutter Lip Height (in) | 0.25 | | Road Run Slope (%) | 1.7 |

Remove & Replace Curb Ramp With Two New Directional Ramps or Equivalent. Grind Gutter Lip.

R204.3, R304.5.3, R302.7.2, STD 1115
