# Access Compliance Report Public Rights-of-Way (Curb Ramps)

Main Street: N/A Cross Street: ROSSMOOR\_CENTER\_WAY Location: S

ADA ID: RPRK211208115544 Ramp Type: Type 1 - Perpendicular Initial Pass/Fail: Pass Overall Compliance: No Severity Score: 5

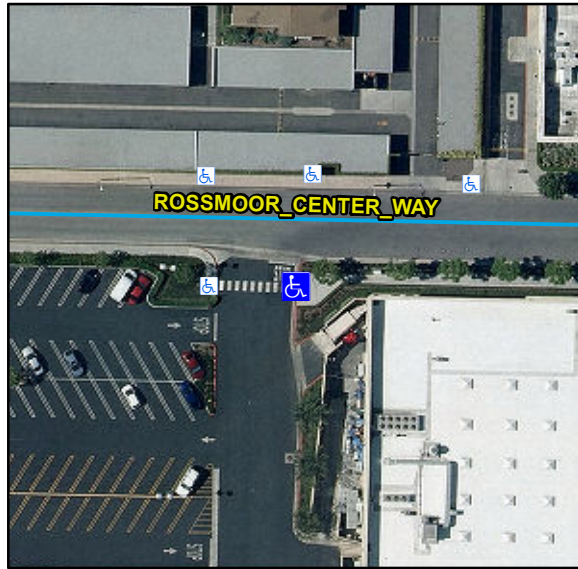
| Compliance | Description | Data | Compliance | Description | Data |
|---|---|---|---|---|---|
| Yes | Gutter Ponding | No | No | Curb Slope | 7.8 |
| No | Gutter Run Slope (%) | 7.1 | | Road Cross Slope (%) | N/A |
| No | Gutter Cross Slope (%) | 3.9 | | | |

Remove & Replace Curb Slope. Remove & Replace Gutter.

R304.2.2, R304.5.4, R304.5.3, STD 1115

Total Cost: \$ 504
