# Access Compliance Report Public Rights-of-Way (Curb Ramps)

Main Street: ROSSMOOR\_CENTER\_WAY Cross Street: N/A Location: SW

ADA ID: RPRK211208115931 Ramp Type: Type 1 - Perpendicular Initial Pass/Fail: Fail Overall Compliance: No Severity Score: 2

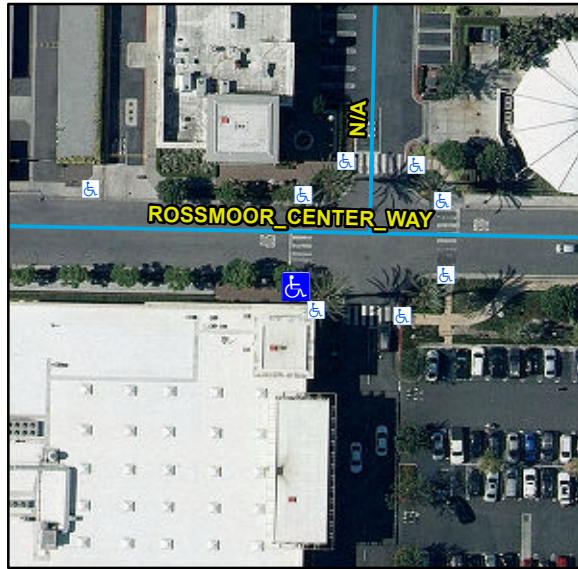
R304.2.2, R304.5.3, STD 1115

| Compliance | Description | Data | Compliance | Description | Data |
|---|---|---|---|---|---|
| No | Ramp Cross Slope (%) | 2.1 | N/A | Flare Traversable LT | N/A |

Remove & Replace Entire Ramp.
