# Access Compliance Report Public Rights-of-Way (Curb Ramps)

Main Street: N/A Cross Street: ROSSMOOR\_CENTER\_WAY Location: SE

ADA ID: RPRK211208120310 Ramp Type: Type 1 - Perpendicular Initial Pass/Fail: Fail Overall Compliance: No Severity Score: 2

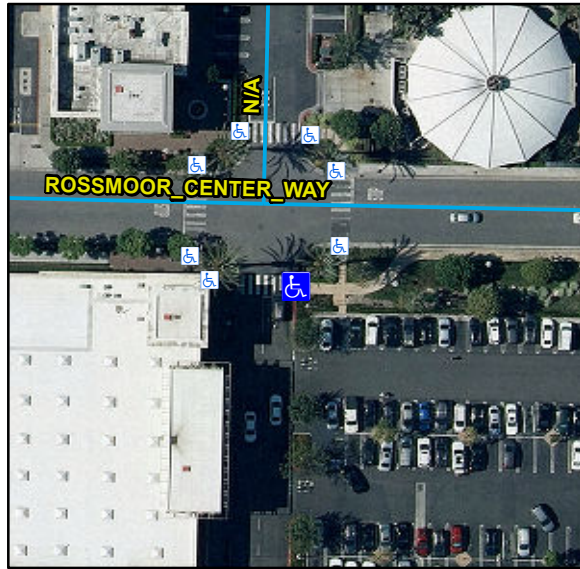
| Compliance | Description | Data | Compliance | Description | Data |
|---|---|---|---|---|---|
| No | Ramp Cross Slope (%) | 2.8 | N/A | Flare Traversable LT | N/A |
| N/A | Gutter Ponding | N/A | No | Curb Slope | 7.1 |

**Remove & Replace Entire Ramp.**

**R304.2.2, R304.5.3, STD 1115**
