# Access Compliance Report Public Rights-of-Way (Curb Ramps)

| Main Street: ROSSMOOR_CENTER_WAY | | Cross Street: N/A | | Location: | SE |
| ADA ID: RPRK211208120442 | Ramp Type: Type 1 - Perpendicular | Initial Pass/Fail: Fail | Overall Compliance: No | Severity Score: | 15 |

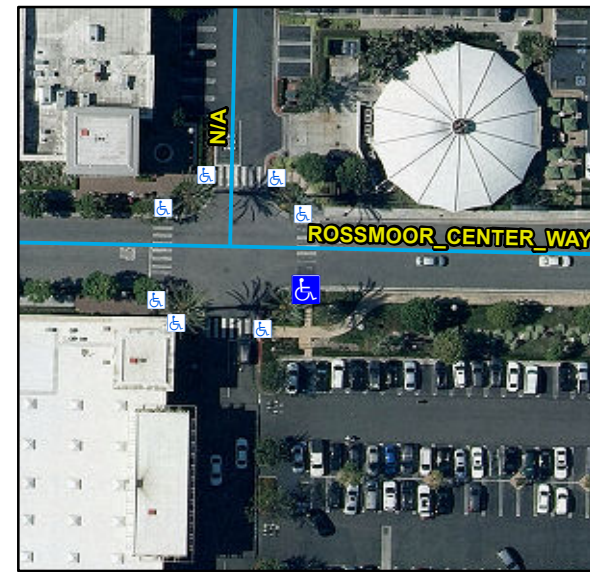
| Compliance | Description | Data | Compliance | Description | Data |
|---|---|---|---|---|---|
| No | Ramp Run Slope (%) | 10.7 | N/A | Flare Slope LT (%) | N/A |

Possible Solutions:

Remove & Replace Entire Ramp.

R304.2.2, STD 1115

Total Cost: \$ 3080
