# Access Compliance Report Public Rights-of-Way (Curb Ramps)

Main Street: ROSSMOOR\_CENTER\_WAY Cross Street: N/A Location: NE

ADA ID: RPRK211208120554 Ramp Type: Type 5 - Combination 2 Initial Pass/Fail: Fail Overall Compliance: No Severity Score: 16

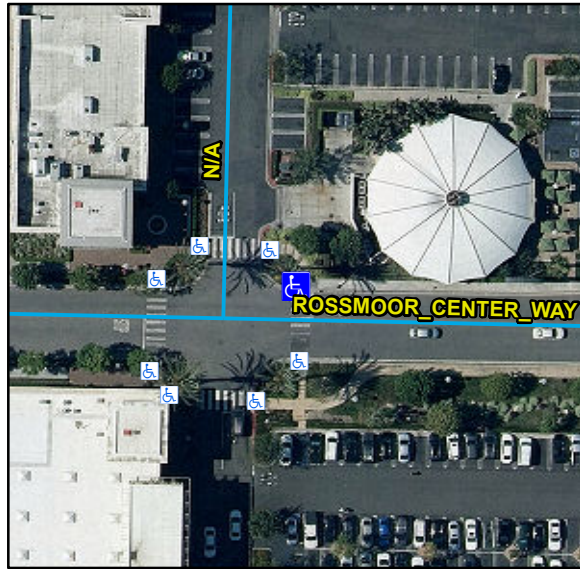
| Compliance | Description | Data | Compliance | Description | Data |
|---|---|---|---|---|---|
| N/A | Ramp Cross Slope LT (%) | N/A | No | Ramp Cross Slope RT (%) | 3.3 |
| No | Ramp Run Slope (%) | 9 | N/A | Flare Slope LT (%) | N/A |
| No | Ramp Cross Slope (%) | 3.3 | N/A | Flare Traversable LT | N/A |

Possible Solutions:

Remove & Replace Entire Ramp.
