# Access Compliance Report Public Rights-of-Way (Curb Ramps)

Main Street: N/A Cross Street: ROSSMOOR\_CENTER\_WAY Location: NE

ADA ID: RPRK211208120809 Ramp Type: Type 1 - Perpendicular Initial Pass/Fail: Fail Overall Compliance: No Severity Score: 2

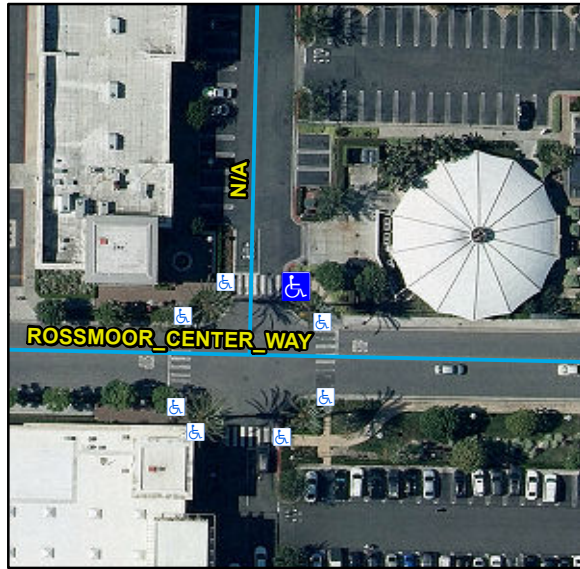
| Compliance | Description | Data | Compliance | Description | Data |
|---|---|---|---|---|---|
| No | Ramp Cross Slope (%) | 3.2 | N/A | Flare Traversable LT | N/A |
| N/A | Gutter Ponding | N/A | No | Curb Slope | 7.9 |

Possible Solutions:

Remove & Replace Entire Ramp.

R304.2.2, R304.5.3, STD 1115
