# Access Compliance Report Public Rights-of-Way (Curb Ramps)

Main Street: N/A Cross Street: ROSSMOOR\_CENTER\_WAY Location: NW

ADA ID: RPRK211208120923 Ramp Type: Type 1 - Perpendicular Initial Pass/Fail: Fail Overall Compliance: No Severity Score: 15

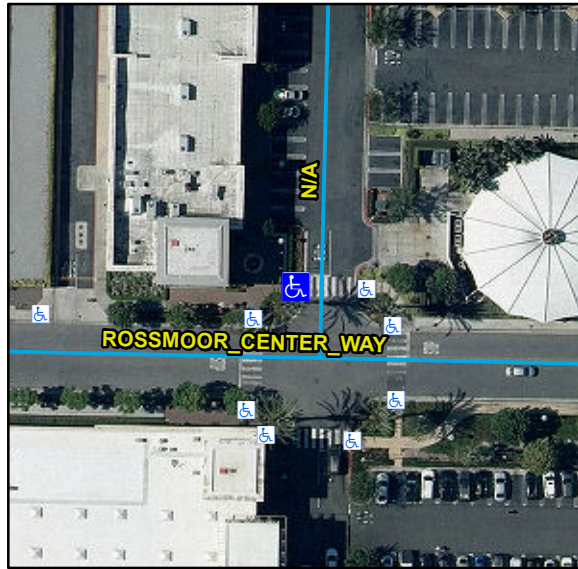
| Compliance | Description | Data | Compliance | Description | Data |
|---|---|---|---|---|---|
| No | Ramp Run Slope (%) | 9.8 | N/A | Flare Slope LT (%) | N/A |

**Remove & Replace Entire Ramp.**

**R304.2.2, STD 1115**
