# Access Compliance Report Public Rights-of-Way (Curb Ramps)

Main Street: ROSSMOOR\_CENTER\_WAY Cross Street: N/A Location: NW

ADA ID: RPRK211208121057 Ramp Type: Type 1 - Perpendicular Initial Pass/Fail: Fail Overall Compliance: No Severity Score: 16

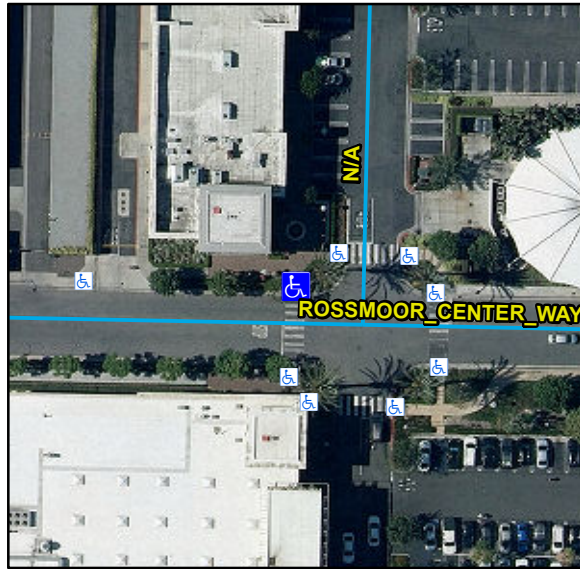
| Compliance | Description | Data | Compliance | Description | Data |
|---|---|---|---|---|---|
| No | Ramp Run Slope (%) | 10.4 | N/A | Flare Slope LT (%) | N/A |
| No | Ramp Cross Slope (%) | 2.3 | N/A | Flare Traversable LT | N/A |

**Remove & Replace Entire Ramp.**

**R304.2.2, R304.5.3, STD 1115**
