# Access Compliance Report Public Rights-of-Way (Curb Ramps)

Main Street: ROSSMOOR\_CENTER\_WAY Cross Street: N/A Location: N

ADA ID: RPRK211208121519 Ramp Type: Type 1 - Perpendicular Initial Pass/Fail: Fail Overall Compliance: No Severity Score: 30

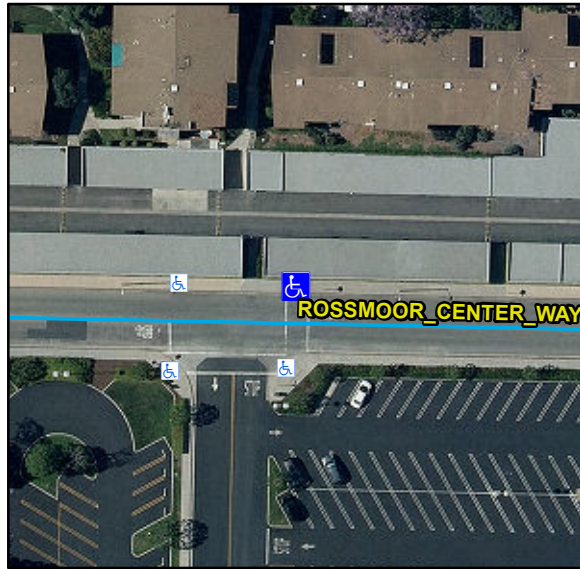
| Compliance | Description | Data | Compliance | Description | Data |
|---|---|---|---|---|---|
| No | Ramp Run Slope (%) | 12.2 | N/A | Flare Slope LT (%) | N/A |

Remove & Replace Entire Ramp.

R204.3, R304.2.2, STD 1115
