# Access Compliance Report Public Rights-of-Way (Curb Ramps)

Main Street: MONTECITO\_RD Cross Street: ROSSMOOR\_CENTER\_WAY Location: NE

ADA ID: RPRK211208121651 Ramp Type: Type 4 - Parallel Initial Pass/Fail: Fail Overall Compliance: No Severity Score: 45

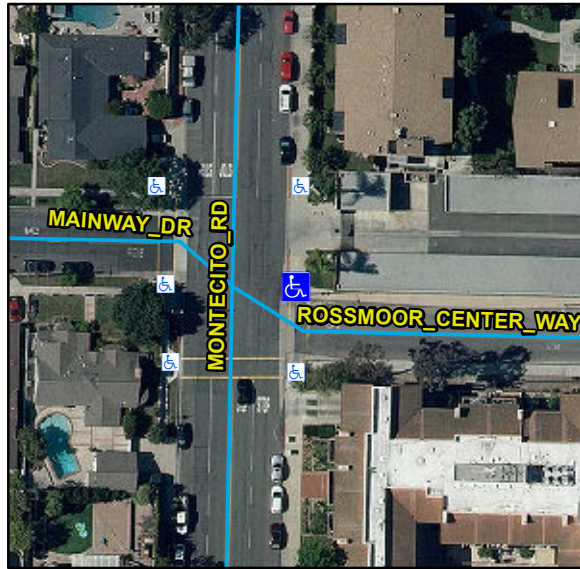
| Compliance | Description | Data | Compliance | Description | Data |
|---|---|---|---|---|---|
| No | Ramp Run Slope LT (%) | 12.9 | Yes | Ramp Run Slope RT (%) | 6.5 |
| No | Ramp Cross Slope LT (%) | 5.9 | No | Ramp Cross Slope RT (%) | 5.1 |

Remove & Replace Curb Ramp With Two New Directional Ramps or Equivalent.

R304.3.2, R304.5.3, STD 1115
