# Access Compliance Report Public Rights-of-Way (Curb Ramps)

Main Street: MONTECITO\_RD Cross Street: MAINWAY\_DR Location: SW

ADA ID: RPRK211208122118 Ramp Type: Type 4 - Parallel Initial Pass/Fail: Fail Overall Compliance: No Severity Score: 45

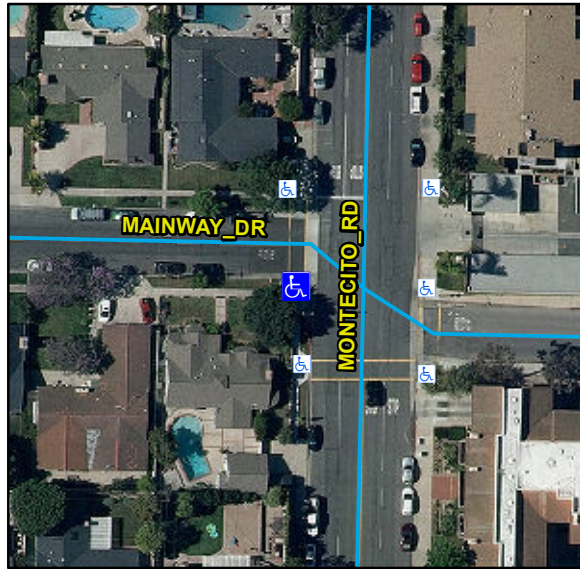
| Compliance | Description | Data | Compliance | Description | Data |
|---|---|---|---|---|---|
| Yes | Ramp Run Slope LT (%) | 1 | No | Ramp Run Slope RT (%) | 9.5 |
| No | Ramp Cross Slope LT (%) | 2.8 | No | Ramp Cross Slope RT (%) | 7.3 |

Remove & Replace Curb Ramp With Two New Directional Ramps or Equivalent.

R204.3, R304.5.3, R304.3.2, STD 1115
