# Access Compliance Report Public Rights-of-Way (Curb Ramps)

Main Street: MAINWAY\_DR Cross Street: MONTECITO\_RD Location: NW

ADA ID: RPRK211208122422 Ramp Type: Type 4 - Parallel Initial Pass/Fail: Fail Overall Compliance: No Severity Score: 30

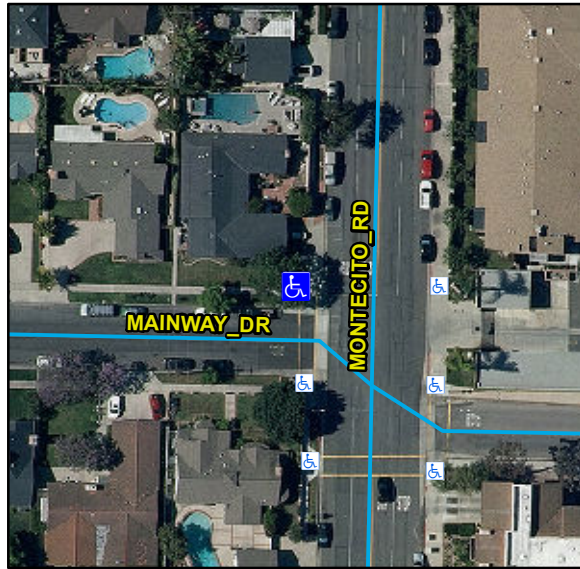
| Compliance | Description | Data | Compliance | Description | Data |
|---|---|---|---|---|---|
| Yes | Ramp Cross Slope LT (%) | 1.9 | No | Ramp Cross Slope RT (%) | 7.5 |

Remove & Replace Curb Ramp With Two New Directional Ramps or Equivalent.

R304.5.3, STD 1115
