# Access Compliance Report Public Rights-of-Way (Curb Ramps)

| Main Street: MONTECITO_RD | | Cross Street: KEMPTON_DR | | Location: | SW |
| ADA ID: RPRK211208122802 | Ramp Type: Type 4 - Parallel | Initial Pass/Fail: Fail | Overall Compliance: No | Severity Score: | 15 |

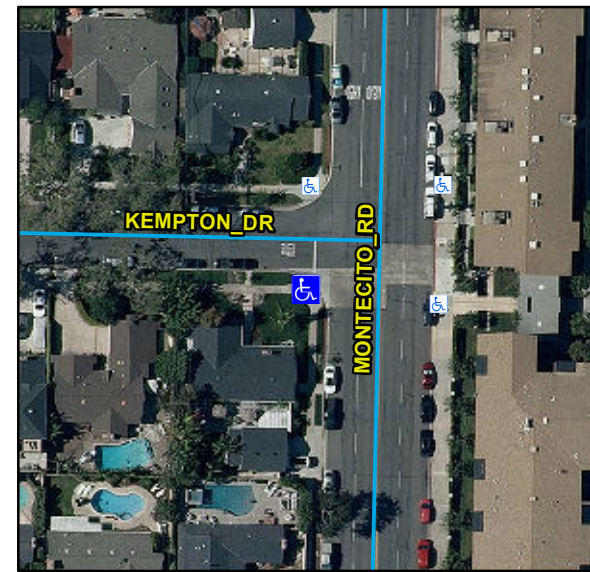
| Compliance | Description | Data | Compliance | Description | Data |
|---|---|---|---|---|---|
| No | Ramp Cross Slope LT (%) | 4.4 | No | Ramp Cross Slope RT (%) | 6.2 |

**Remove & Replace Curb Ramp With Two New Directional Ramps or Equivalent.**

**R304.5.3, STD 1115**

Total Cost: \$ 4000
