# Access Compliance Report Public Rights-of-Way (Curb Ramps)

Main Street: KEMPTON\_DR Cross Street: MONTECITO\_RD Location: NW

ADA ID: RPRK211208123138 Ramp Type: Type 4 - Parallel Initial Pass/Fail: Fail Overall Compliance: No Severity Score: 15

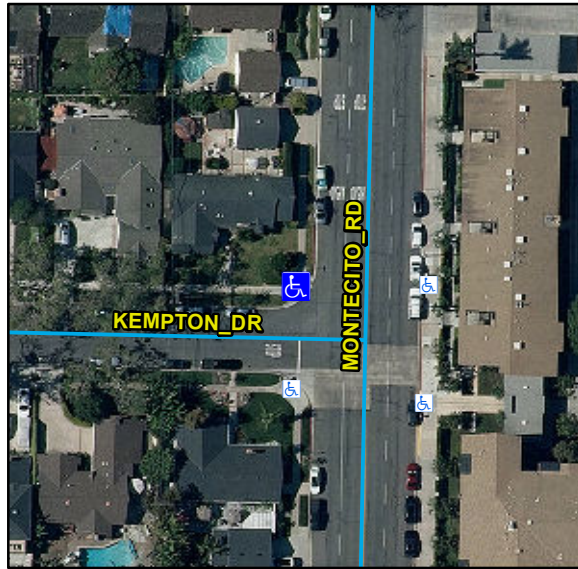
| Compliance | Description | Data | Compliance | Description | Data |
|---|---|---|---|---|---|
| No | Ramp Cross Slope LT (%) | 2.1 | No | Ramp Cross Slope RT (%) | 7 |

Remove & Replace Curb Ramp With Two New Directional Ramps or Equivalent.

R304.5.3, STD 1115
