# Access Compliance Report Public Rights-of-Way (Curb Ramps)

Main Street: CHAUCER\_RD Cross Street: KEMPTON\_DR Location: NE

ADA ID: RPRK211208123701 Ramp Type: Type 1 - Perpendicular Diagonal Initial Pass/Fail: Fail Overall Compliance: No Severity Score: 2

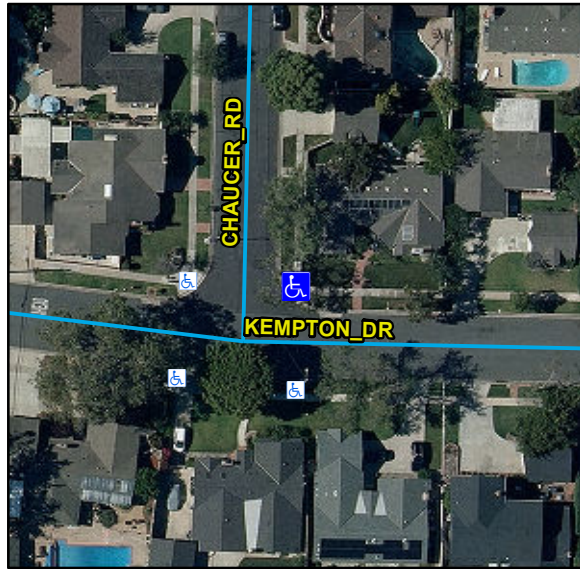
| Compliance | Description | Data | Compliance | Description | Data |
|---|---|---|---|---|---|
| No | Ramp Cross Slope (%) | 3.7 | N/A | Flare Traversable LT | N/A |

Remove & Replace Curb Ramp With Two New Directional Ramps or Equivalent.
