# Access Compliance Report Public Rights-of-Way (Curb Ramps)

Main Street: KEMPTON\_DR Cross Street: CHAUCER\_RD Location: NW

ADA ID: RPRK211208123901 Ramp Type: Type 1 - Perpendicular Diagonal Initial Pass/Fail: Pass Overall Compliance: No Severity Score: 19

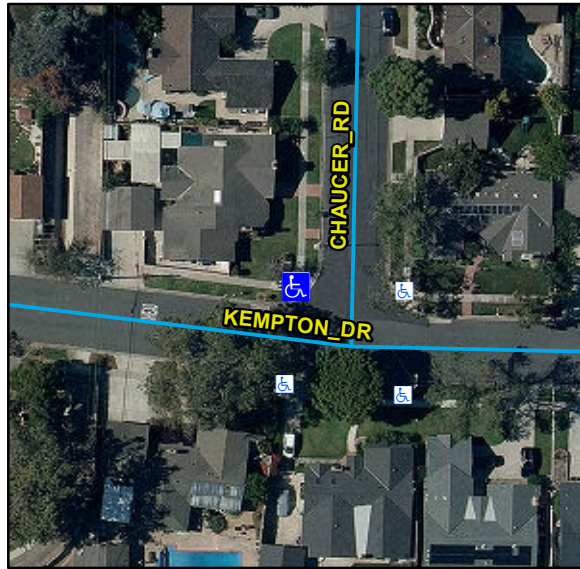
| Compliance | Description | Data | Compliance | Description | Data |
|---|---|---|---|---|---|
| Yes | Landing Cross Slope (%) | 1.5 | No | DWS Provided | No |
| Yes | Gutter Ponding | No | No | Curb Slope | 6.8 |
| No | Gutter Lip Height (in) | 0.25 | | Road Run Slope (%) | 2.9 |
| No | Gutter Run Slope (%) | 14.1 | | Road Cross Slope (%) | 7.2 |
| No | Gutter Cross Slope (%) | 4.4 | | | |

Remove & Replace Curb Ramp With Two New Directional Ramps or Equivalent. Remove & Replace Gutter.

R304.2.2, R204.3, R304.2.1, R305, R302.7.2, R304.5.4, R304.5.3, STD 1115
