# Access Compliance Report Public Rights-of-Way (Curb Ramps)

Main Street: SILVER\_FOX\_RD Cross Street: KEMPTON\_DR Location: NE

ADA ID: RPRK211208124218 Ramp Type: Type 1 - Perpendicular Diagonal Initial Pass/Fail: Fail Overall Compliance: No Severity Score: 2

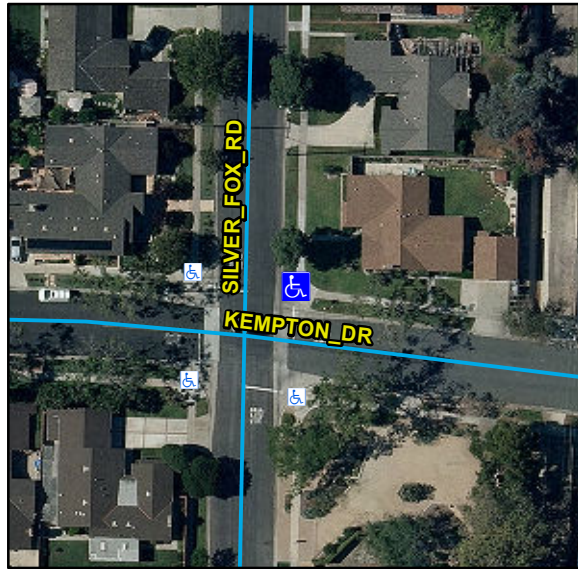
| Compliance | Description | Data | Compliance | Description | Data |
|---|---|---|---|---|---|
| No | Ramp Cross Slope (%) | 2.3 | N/A | Flare Traversable LT | N/A |
| No | Gutter Lip Height (in) | 0.25 | | Road Run Slope (%) | 1.7 |

Remove & Replace Curb Ramp With Two New Directional Ramps or Equivalent. Grind Gutter Lip.

R204.3, R304.5.3, R302.7.2, STD 1115
