# Access Compliance Report Public Rights-of-Way (Curb Ramps)

Main Street: KEMPTON\_DR Cross Street: SILVER\_FOX\_RD Location: NW

ADA ID: RPRK211208124451 Ramp Type: Type 1 - Perpendicular Diagonal Initial Pass/Fail: Pass Overall Compliance: No Severity Score: 10

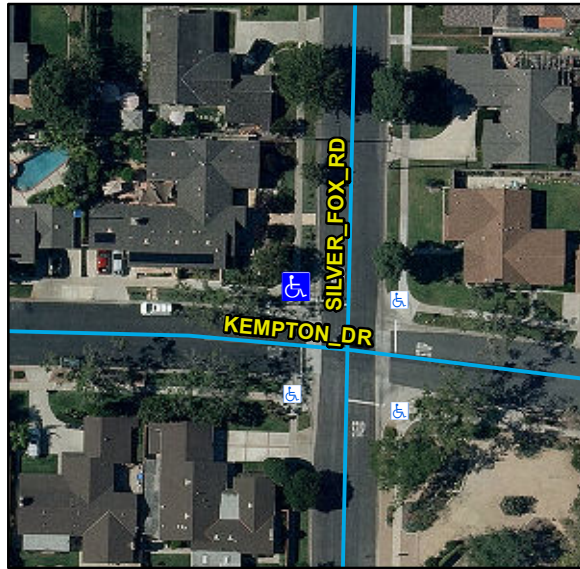
| Compliance | Description | Data | Compliance | Description | Data |
|---|---|---|---|---|---|
| N/A | Ramp Length (in) | 83 | N/A | Flare Type LT | |
| Yes | Ramp Width (in) | 48 | | | Sloped |
| Yes | Ramp Run Slope (%) | 5.5 | N/A | Flare Slope LT (%) | 2.6 |
| Yes | Ramp Cross Slope (%) | 1 | N/A | Flare Traversable LT | No |
| Yes | Landing Cross Slope (%) | 1 | No | DWS Provided | No |
| No | Gutter Cross Slope (%) | 2.8 | | | |

Remove & Replace Curb Ramp With Two New Directional Ramps or Equivalent. Remove & Replace Gutter.
