# Access Compliance Report Public Rights-of-Way (Curb Ramps)

Main Street: SILVER\_FOX\_RD Cross Street: KEMPTON\_DR Location: SW

ADA ID: RPRK211208124759 Ramp Type: Type 1 - Perpendicular Diagonal Initial Pass/Fail: Fail Overall Compliance: No Severity Score: 2

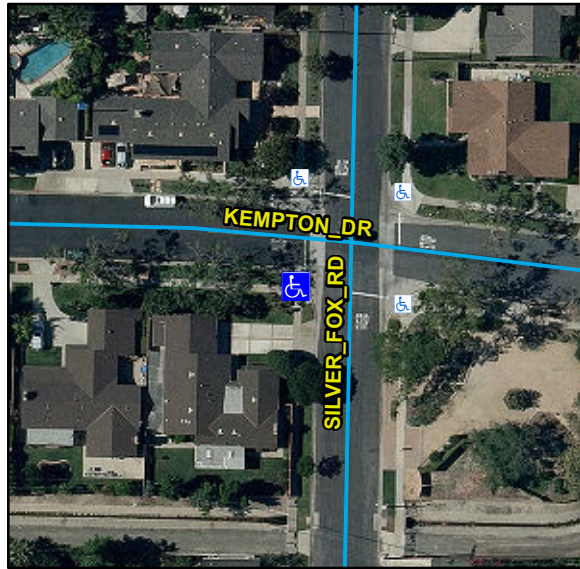
| Compliance | Description | Data | Compliance | Description | Data |
|---|---|---|---|---|---|
| No | Ramp Cross Slope (%) | 2.4 | N/A | Flare Traversable LT | N/A |
| No | Gutter Lip Height (in) | 0.25 | | Road Run Slope (%) | 3.9 |

**Remove & Replace Curb Ramp With Two New Directional Ramps or Equivalent. Grind Gutter Lip.**

**R204.3, R304.5.3, R302.7.2, STD 1115**

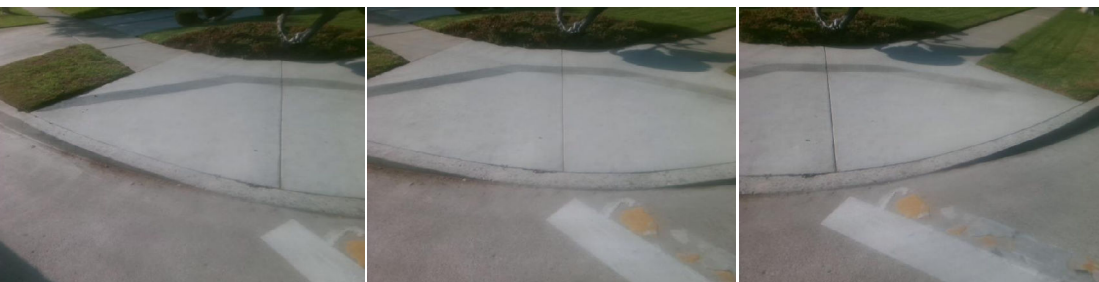
| Compliance | Description | Data | Compliance | Description | Data |
|---|---|---|---|---|---|
| Yes | Overall Surface Condition: Acceptable | | No | Perp Joint Present | No |
