# Access Compliance Report

## Public Rights-of-Way

### (Curb Ramps)

Main Street: KEMPTON\_DR Cross Street: SILVER\_FOX\_RD Location: SE

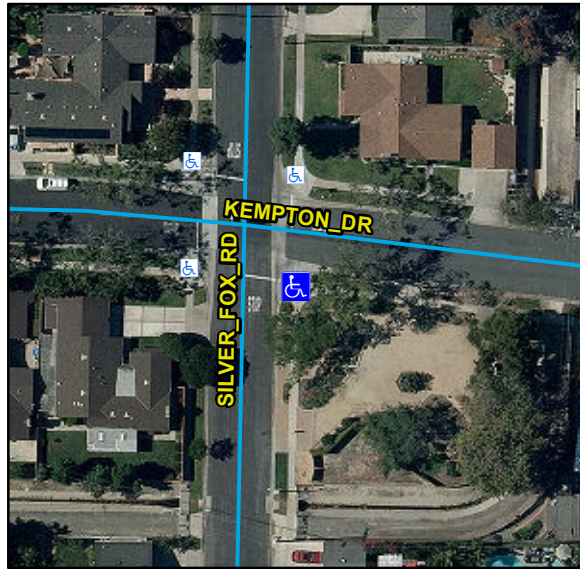
ADA ID: RPRK211208124957 Ramp Type: Type 1 - Perpendicular Diagonal Initial Pass/Fail: Fail Overall Compliance: No Severity Score: 2

| Compliance | Description | Data | Compliance | Description | Data |
|---|---|---|---|---|---|
| No | Ramp Cross Slope (%) | 2.5 | N/A | Flare Traversable LT | N/A |

**Remove & Replace Curb Ramp With Two New Directional Ramps or Equivalent.**

**R204.3, R304.5.3, STD 1115**

Total Cost: \$ 6160
