# Access Compliance Report Public Rights-of-Way (Curb Ramps)

Main Street: SILVER\_FOX\_RD Cross Street: MAINWAY\_DR Location: NE

ADA ID: RPRK211208125222 Ramp Type: Type 1 - Perpendicular Diagonal Initial Pass/Fail: Fail Overall Compliance: No Severity Score: 2

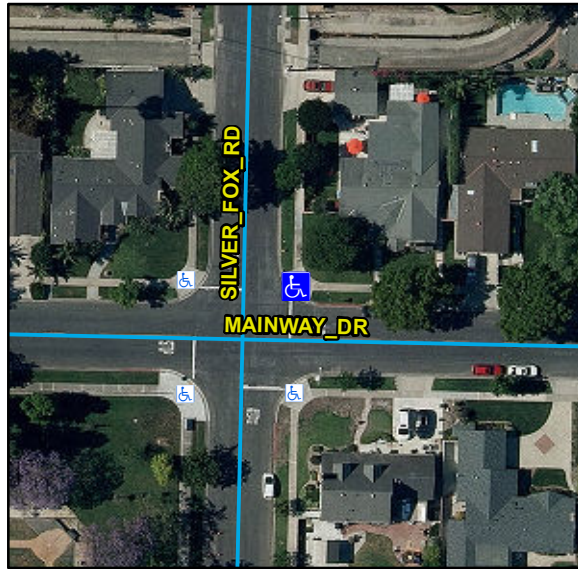
| Compliance | Description | Data | Compliance | Description | Data |
|---|---|---|---|---|---|
| No | Ramp Cross Slope (%) | 2.1 | N/A | Flare Traversable LT | N/A |

Remove & Replace Curb Ramp With Two New Directional Ramps or Equivalent.

R204.3, R304.5.3, STD 1115
