# Access Compliance Report Public Rights-of-Way (Curb Ramps)

Main Street: MAINWAY\_DR Cross Street: SILVER\_FOX\_RD Location: NW

ADA ID: RPRK211208125447 Ramp Type: Type 1 - Perpendicular Diagonal Initial Pass/Fail: Pass Overall Compliance: No Severity Score: 16

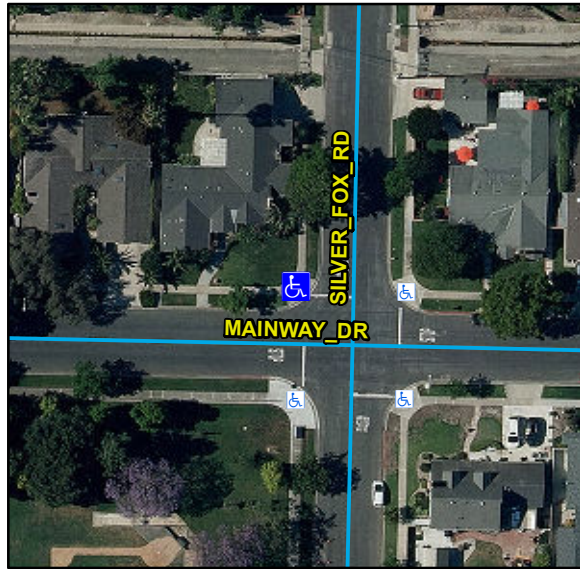
| Compliance | Description | Data | Compliance | Description | Data |
|---|---|---|---|---|---|
| No | Landing Cross Slope (%) | 3.6 | No | DWS Provided | No |
| Yes | Gutter Ponding | No | No | Curb Slope | 11.5 |
| No | Gutter Run Slope (%) | 5.4 | | Road Cross Slope (%) | 7.9 |
| No | Gutter Cross Slope (%) | 2.5 | | | |

Remove & Replace Curb Ramp With Two New Directional Ramps or Equivalent. Remove & Replace Gutter.

R304.2.2, R204.3, R304.5.3, R305, R304.5.4, STD 1115
