# Access Compliance Report Public Rights-of-Way (Curb Ramps)

Main Street: SILVER\_FOX\_RD Cross Street: MAINWAY\_DR Location: SW

ADA ID: RPRK211208125749 Ramp Type: Type 1 - Perpendicular Diagonal Initial Pass/Fail: Fail Overall Compliance: No Severity Score: 2

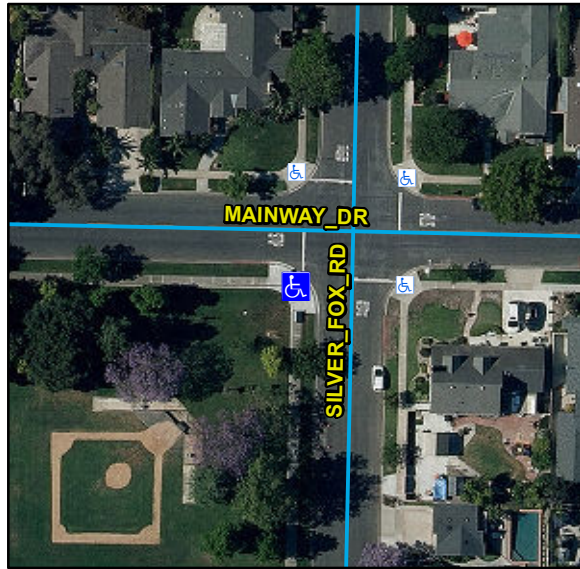
| Compliance | Description | Data | Compliance | Description | Data |
|---|---|---|---|---|---|
| No | Ramp Cross Slope (%) | 2.3 | N/A | Flare Traversable LT | N/A |

Remove & Replace Curb Ramp With Two New Directional Ramps or Equivalent.

R304.5.3, STD 1115
