# Access Compliance Report Public Rights-of-Way (Curb Ramps)

Main Street: MAINWAY\_DR Cross Street: SILVER\_FOX\_RD Location: SE

ADA ID: RPRK211208125947 Ramp Type: Type 1 - Perpendicular Diagonal Initial Pass/Fail: Fail Overall Compliance: No Severity Score: 2

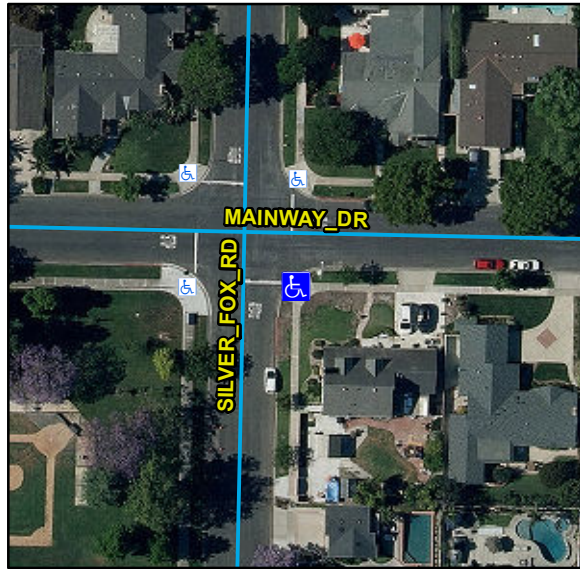
| Compliance | Description | Data | Compliance | Description | Data |
|---|---|---|---|---|---|
| No | Ramp Cross Slope (%) | 2.7 | N/A | Flare Traversable LT | N/A |

**Remove & Replace Curb Ramp With Two New Directional Ramps or Equivalent.**
