# Access Compliance Report Public Rights-of-Way (Curb Ramps)

Main Street: SILVER\_FOX\_RD Cross Street: TUCKER\_LN Location: NE

ADA ID: RPRK211208130201 Ramp Type: Type 1 - Perpendicular Diagonal Initial Pass/Fail: Pass Overall Compliance: No Severity Score: 10

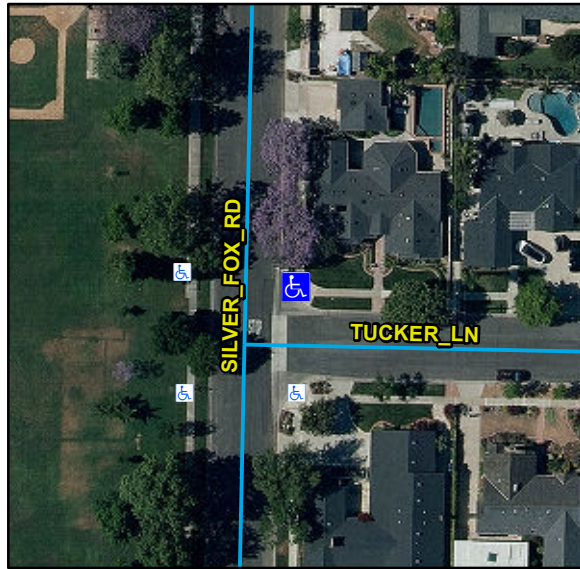
| Compliance | Description | Data | Compliance | Description | Data |
|---|---|---|---|---|---|
| Yes | Landing Cross Slope (%) | 1.8 | No | DWS Provided | No |

Remove & Replace Curb Ramp With Two New Directional Ramps or Equivalent.

R204.3, R305, STD 1115
