# Access Compliance Report Public Rights-of-Way (Curb Ramps)

Main Street: TUCKER\_LN Cross Street: SILVER\_FOX\_RD Location: SE

ADA ID: RPRK211208130638 Ramp Type: Type 1 - Perpendicular Diagonal Initial Pass/Fail: Fail Overall Compliance: No Severity Score: 2

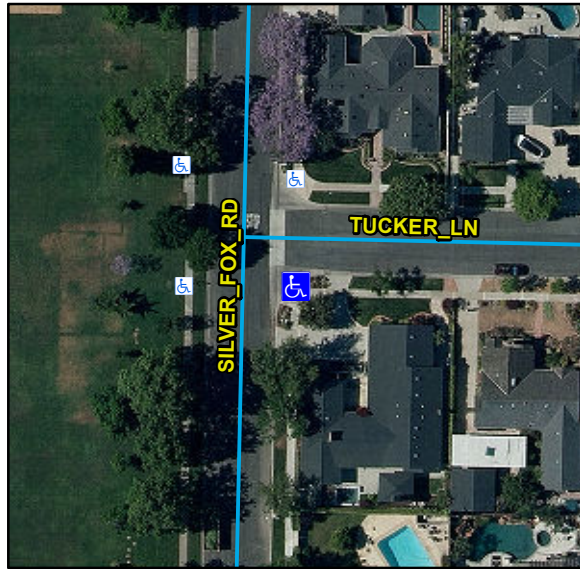
| Compliance | Description | Data | Compliance | Description | Data |
|---|---|---|---|---|---|
| No | Ramp Cross Slope (%) | 2.9 | N/A | Flare Traversable LT | N/A |

**Remove & Replace Curb Ramp With Two New Directional Ramps or Equivalent.**

**R204.3, R304.5.3, STD 1115**
