# Access Compliance Report Public Rights-of-Way (Curb Ramps)

Main Street: BLUME\_DR Cross Street: SILVER\_FOX\_RD Location: NW

ADA ID: RPRK211208130817 Ramp Type: Type 1 - Perpendicular Diagonal Initial Pass/Fail: Fail Overall Compliance: No Severity Score: 15

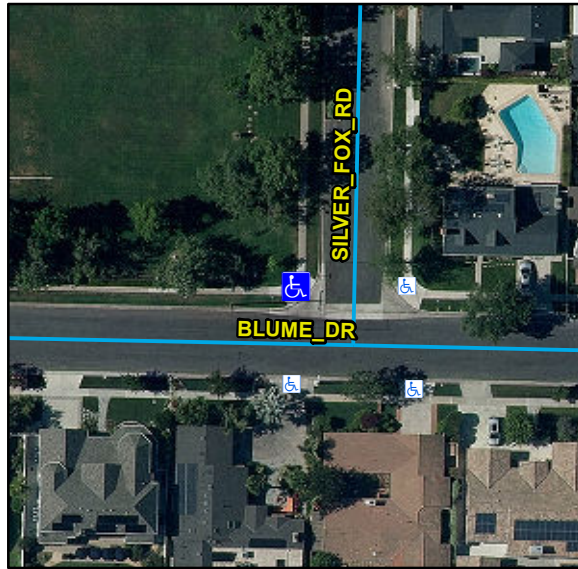
| Compliance | Description | Data | Compliance | Description | Data |
|---|---|---|---|---|---|
| No | Ramp Run Slope (%) | 8.5 | N/A | Flare Slope LT (%) | N/A |

**Remove & Replace Curb Ramp With Two New Directional Ramps or Equivalent.**

**R304.2.2, STD 1115**
