# Access Compliance Report Public Rights-of-Way (Curb Ramps)

Main Street: SILVER\_FOX\_RD Cross Street: BLUME\_DR Location: NE

ADA ID: RPRK211208131132 Ramp Type: Type 1 - Perpendicular Diagonal Initial Pass/Fail: Fail Overall Compliance: No Severity Score: 2

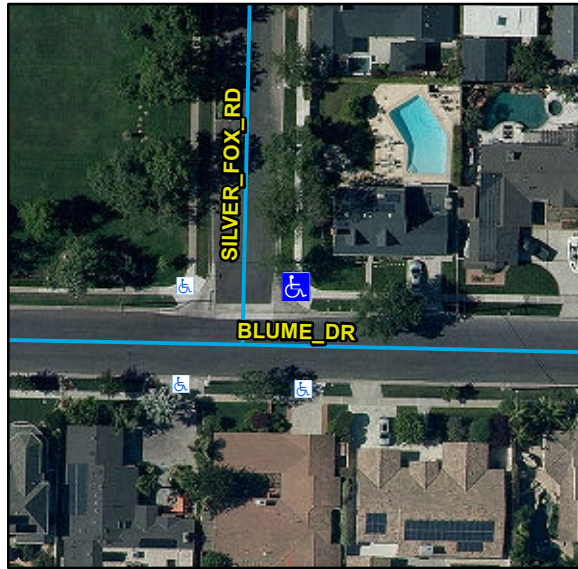
| Compliance | Description | Data | Compliance | Description | Data |
|---|---|---|---|---|---|
| No | Ramp Cross Slope (%) | 3.1 | N/A | Flare Traversable LT | N/A |

**Remove & Replace Curb Ramp With Two New Directional Ramps or Equivalent.**

**R204.3, R304.5.3, STD 1115**
