# Access Compliance Report Public Rights-of-Way (Curb Ramps)

Main Street: SALMON\_DR Cross Street: BLUME\_DR Location: SW

ADA ID: RPRK211208131512 Ramp Type: Type 1 - Perpendicular Diagonal Initial Pass/Fail: Pass Overall Compliance: No Severity Score: 15

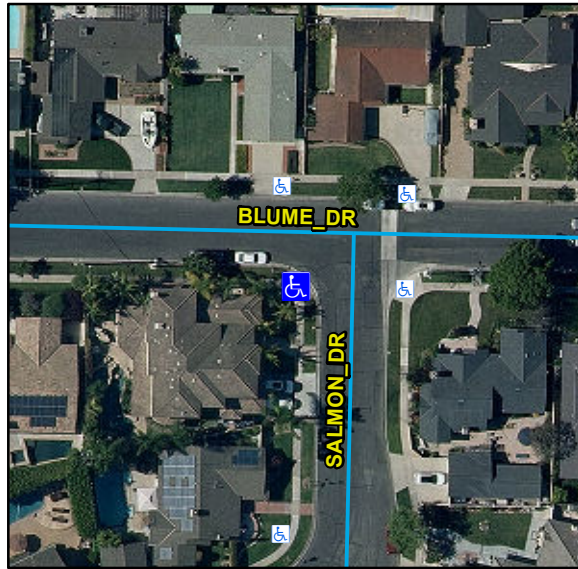
| Compliance | Description | Data | Compliance | Description | Data |
|---|---|---|---|---|---|
| Yes | Landing Cross Slope (%) | 0.1 | No | DWS Provided | No |
| No | Gutter Run Slope (%) | 5.7 | | Road Cross Slope (%) | 6 |

Remove & Replace Curb Ramp With Two New Directional Ramps or Equivalent. Remove & Replace Gutter.

R204.3, R305, R304.5.4, STD 1115
