# Access Compliance Report Public Rights-of-Way (Curb Ramps)

Main Street: BLUME\_DR Cross Street: SALMON\_DR Location: SE

ADA ID: RPRK211208131750 Ramp Type: Type 1 - Perpendicular Diagonal Initial Pass/Fail: Pass Overall Compliance: No Severity Score: 12

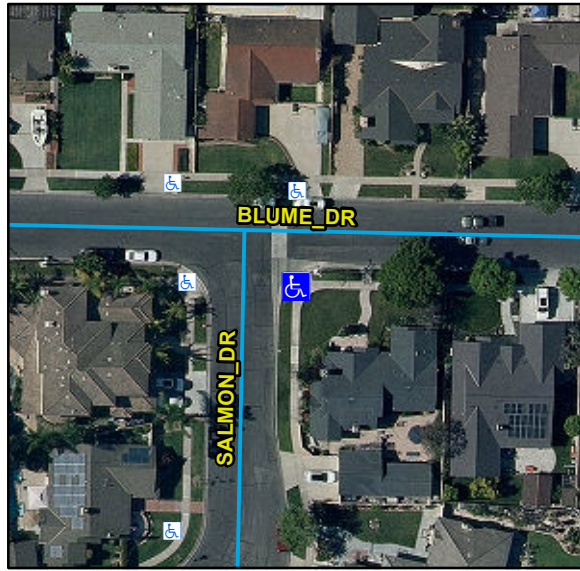
| Compliance | Description | Data | Compliance | Description | Data |
|---|---|---|---|---|---|
| No | Landing Cross Slope (%) | 2.6 | No | DWS Provided | No |

**Remove & Replace Curb Ramp With Two New Directional Ramps or Equivalent.**

**R204.3, R304.5.3, R305, STD 1115**
