# Access Compliance Report Public Rights-of-Way (Curb Ramps)

Main Street: BLUME\_DR Cross Street: TUCKER\_LN Location: SW

ADA ID: RPRK211208132420 Ramp Type: Type 1 - Perpendicular Diagonal Initial Pass/Fail: Pass Overall Compliance: No Severity Score: 10

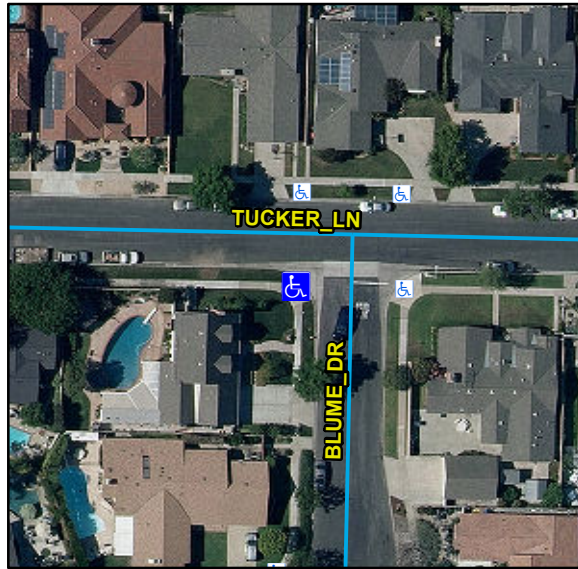
| Compliance | Description | Data | Compliance | Description | Data |
|---|---|---|---|---|---|
| No | Landing Cross Slope (%) | 3.8 | No | DWS Provided | No |

**Remove & Replace Curb Ramp With Two New Directional Ramps or Equivalent.**

**R204.3, R304.5.3, R305, STD 1115**
