# Access Compliance Report Public Rights-of-Way (Curb Ramps)

Main Street: TUCKER\_LN Cross Street: BLUME\_DR Location: SE

ADA ID: RPRK211208132816 Ramp Type: Type 1 - Perpendicular Diagonal Initial Pass/Fail: Pass Overall Compliance: No Severity Score: 10

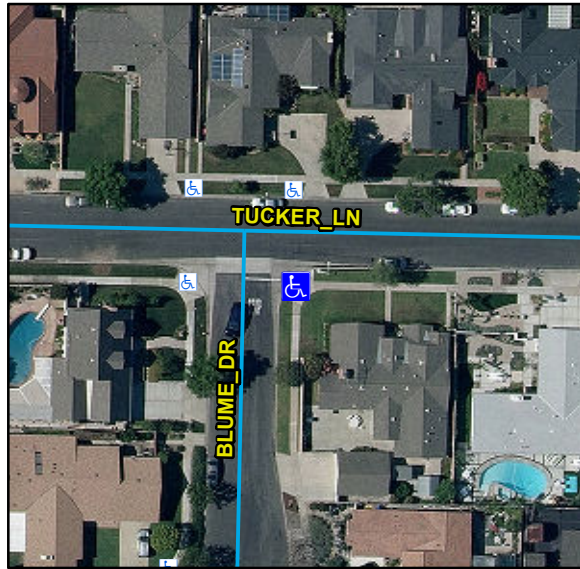
| Compliance | Description | Data | Compliance | Description | Data |
|---|---|---|---|---|---|
| Yes | Landing Cross Slope (%) | 1.3 | No | DWS Provided | No |
| No | Gutter Cross Slope (%) | 5 | | | |

**Remove & Replace Curb Ramp With Two New Directional Ramps or Equivalent. Remove & Replace Gutter.**

**R204.3, R305, R304.5.3, STD 1115**
