# Access Compliance Report Public Rights-of-Way (Curb Ramps)

Main Street: ORLANDO\_RD Cross Street: BRADBURY\_RD Location: NE

ADA ID: RPRK211208134613 Ramp Type: Type 1 - Perpendicular Diagonal Initial Pass/Fail: Fail Overall Compliance: No Severity Score: 2

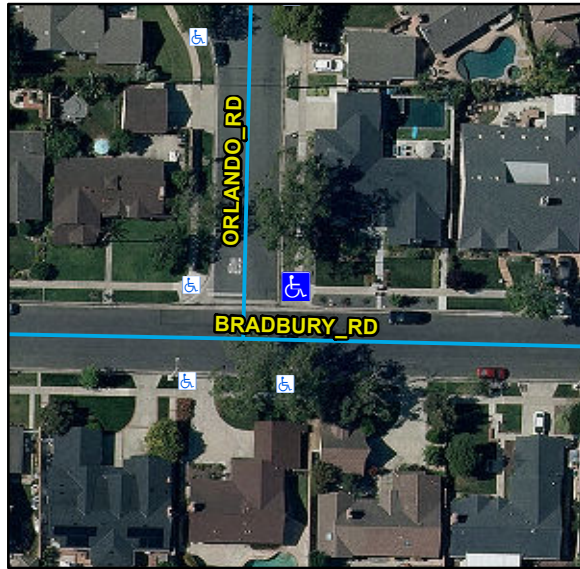
| Compliance | Description | Data | Compliance | Description | Data |
|---|---|---|---|---|---|
| No | Ramp Cross Slope (%) | 2.8 | N/A | Flare Traversable LT | N/A |

**Remove & Replace Curb Ramp With Two New Directional Ramps or Equivalent.**

**R204.3, R304.5.3, STD 1115**
