# Access Compliance Report Public Rights-of-Way (Curb Ramps)

Main Street: BRADBURY\_RD Cross Street: ORLANDO\_RD Location: NW

ADA ID: RPRK211208134918 Ramp Type: Type 1 - Perpendicular Diagonal Initial Pass/Fail: Pass Overall Compliance: No Severity Score: 15

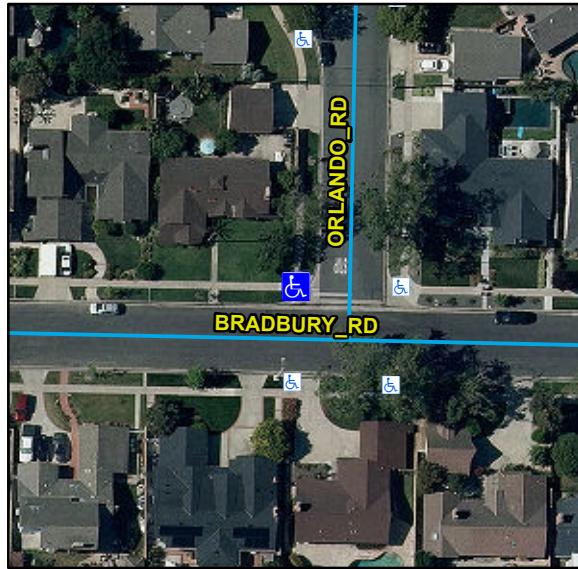
| Compliance | Description | Data | Compliance | Description | Data |
|---|---|---|---|---|---|
| Yes | Landing Cross Slope (%) | 0.3 | No | DWS Provided | No |
| No | Gutter Run Slope (%) | 5.1 | | Road Cross Slope (%) | 0.4 |
| No | Gutter Cross Slope (%) | 3.5 | | | |

Remove & Replace Curb Ramp With Two New Directional Ramps or Equivalent. Remove & Replace Gutter.

R204.3, R305, R304.5.4, R304.5.3, STD 1115
