# Access Compliance Report Public Rights-of-Way (Curb Ramps)

Main Street: SALMON\_DR Cross Street: OAK\_WAY\_DR Location: NW

ADA ID: RPRK211209112553 Ramp Type: Type 1 - Perpendicular Diagonal Initial Pass/Fail: Pass Overall Compliance: No Severity Score: 15

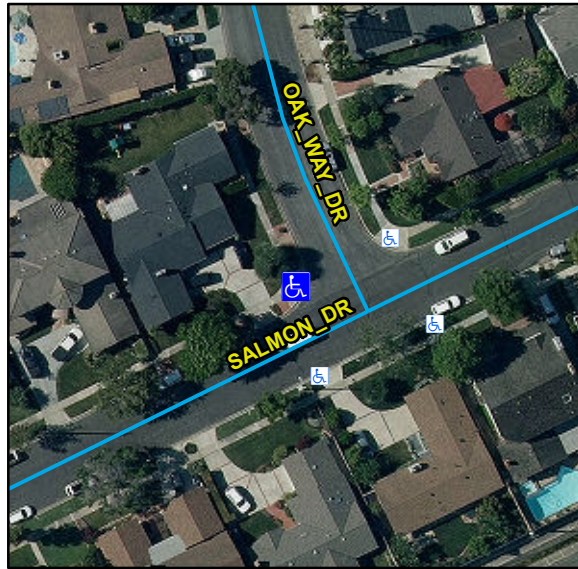
| Compliance | Description | Data | Compliance | Description | Data |
|---|---|---|---|---|---|
| Yes | Landing Cross Slope (%) | 0.5 | No | DWS Provided | No |
| No | Gutter Run Slope (%) | 8 | | Road Cross Slope (%) | 7.7 |
| No | Gutter Cross Slope (%) | 3 | | | |

Remove & Replace Curb Ramp With Two New Directional Ramps or Equivalent. Remove & Replace Gutter.

R204.3, R305, R304.5.4, R304.5.3, STD 1115
